Castlehead Fishery

Castlehead Fishery – Background

Castlehead Fishery Improvements To-Date

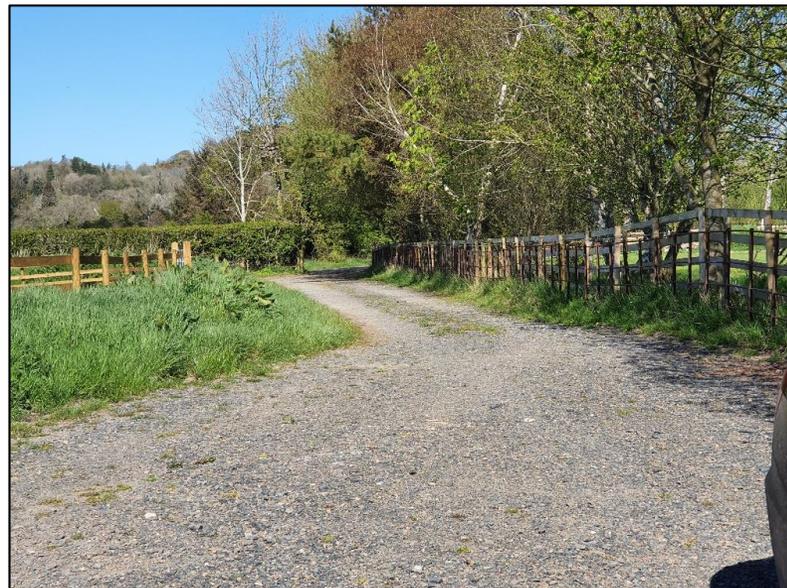
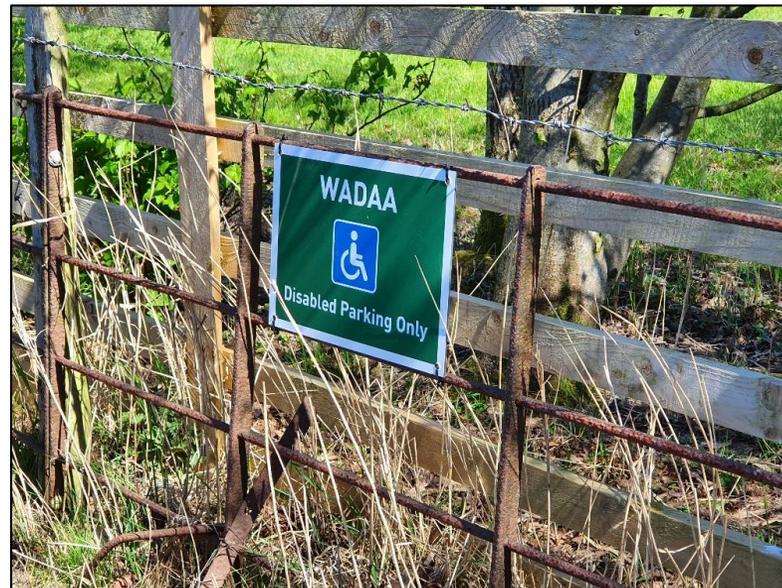
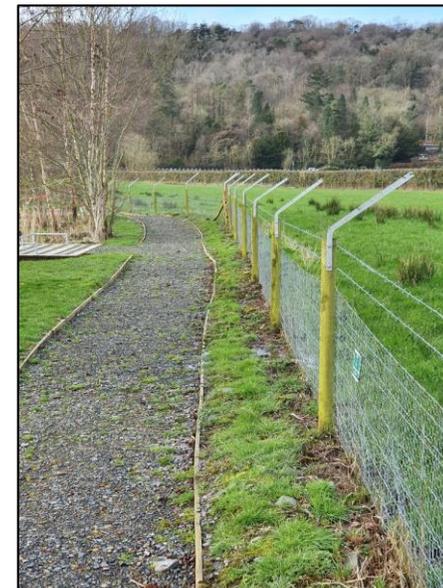
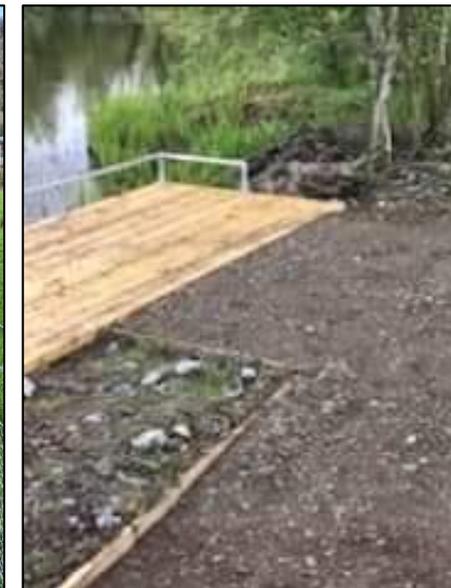
WADAA worked hard during early 2019 to significantly improve the facilities at Castlehead Fishery, placing particular emphasis on making the venue accessible for disabled and mobility impaired anglers. Working with a number of partners, the club constructed 18 new platforms, including some specifically designed, over-sized platforms for disabled access and coaching. To aid access further, a new car park and access road were also constructed, which necessitated the club gaining the requisite planning permissions. The new car parking allowed the club to create dedicated disabled parking bays adjacent to the water. This parking was also integrated with a new perimeter path around the lake.

The construction project was large – using over 400 tonnes of stone, huge amounts of tanalised timber and cutting down tonnes of overgrown trees to make the fishery accessible. The work was carried out by members, local contractors and with additional support from local businesses.

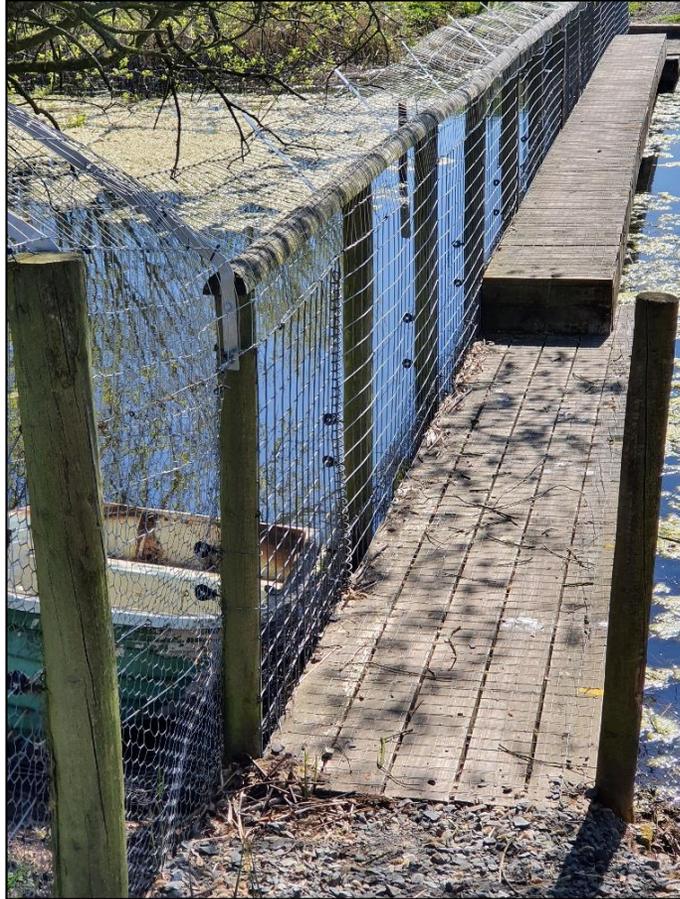
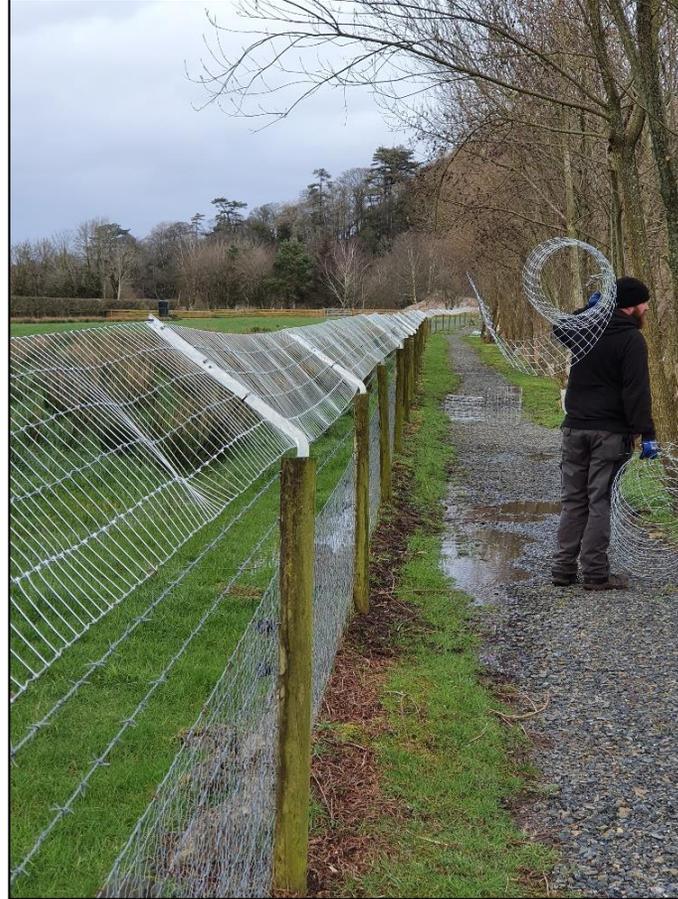
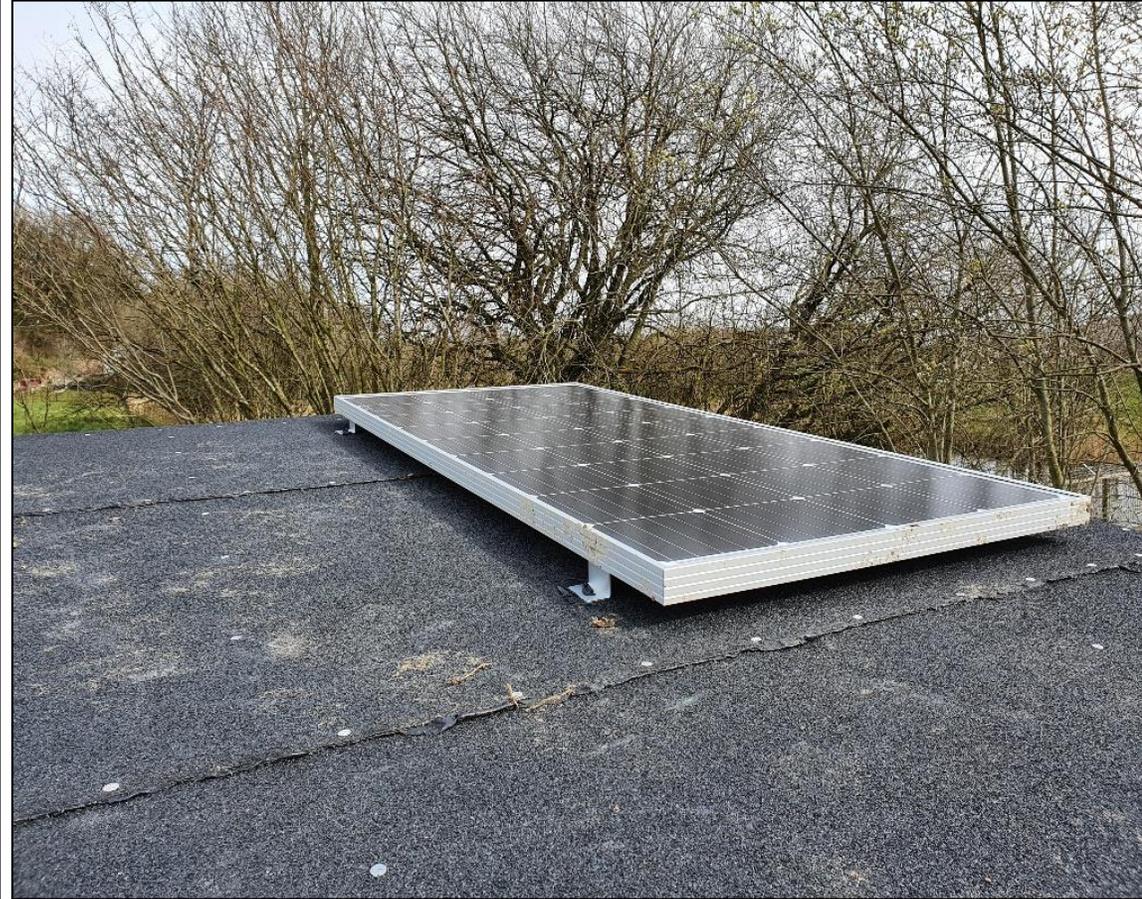
The venue benefits from a perimeter otter protective fence. The fence is electrified and has been further enhanced with an overhang. The power is supplied by battery with a solar panel back-up. However, the routing of the fence is complex as, due to ownership right issues, the fence protection crosses the lake adjacent to a wooden bridge.

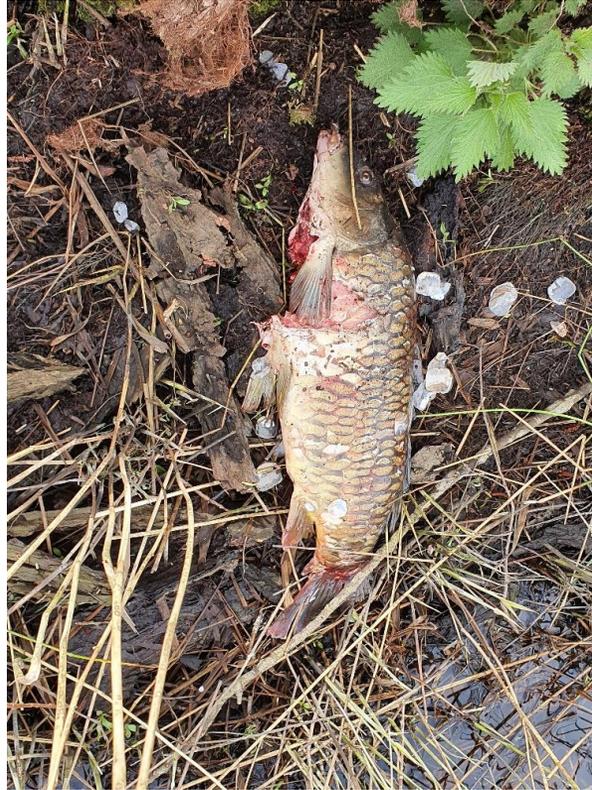
Despite several attempts to produce an engineered solution to prevent otter ingress under the bridge, the lake has continued to suffer otter predation.

The club have made numerous attempts to secure the area under the bridge including deploying a team of divers. However, each attempt has failed to prevent further otter ingress

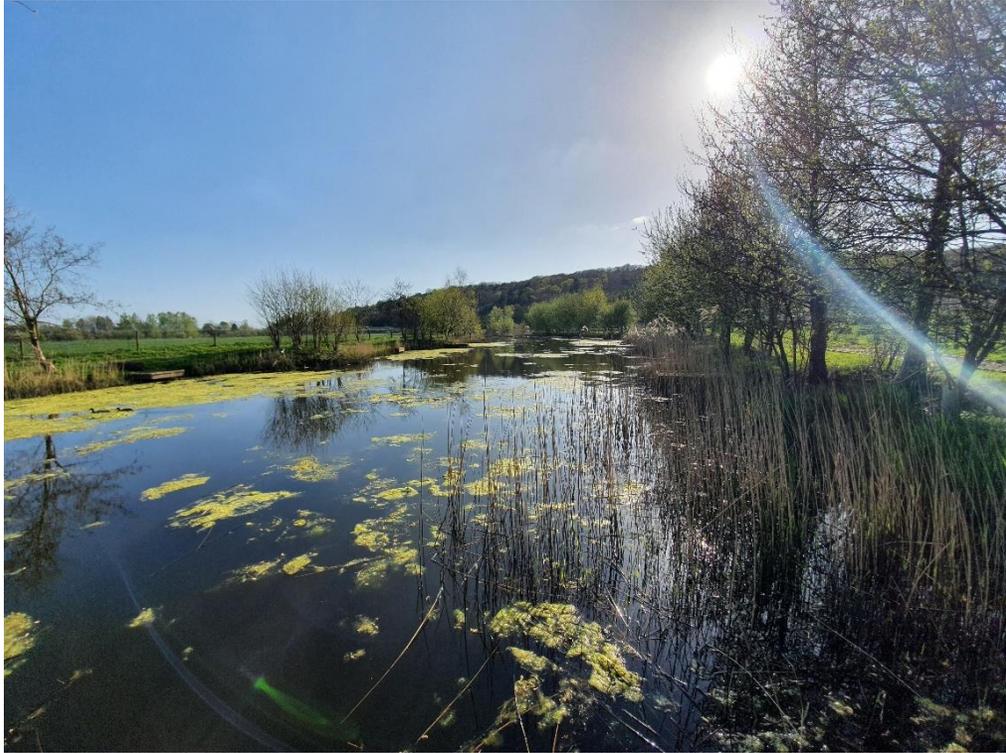
As previously noted, the lake was formed in the late C19 when the River Winster was diverted to create farm land. The lake bed profile is therefore typically concave and over the years, significant accumulations of organic silt have built up. These silts are contributing to high phosphate and nitrate levels in the lake (as noted during water quality tests carried out by the Environment Agency in 2019). This chemical composition increases weed growth, which then adds further to the silt accumulation.

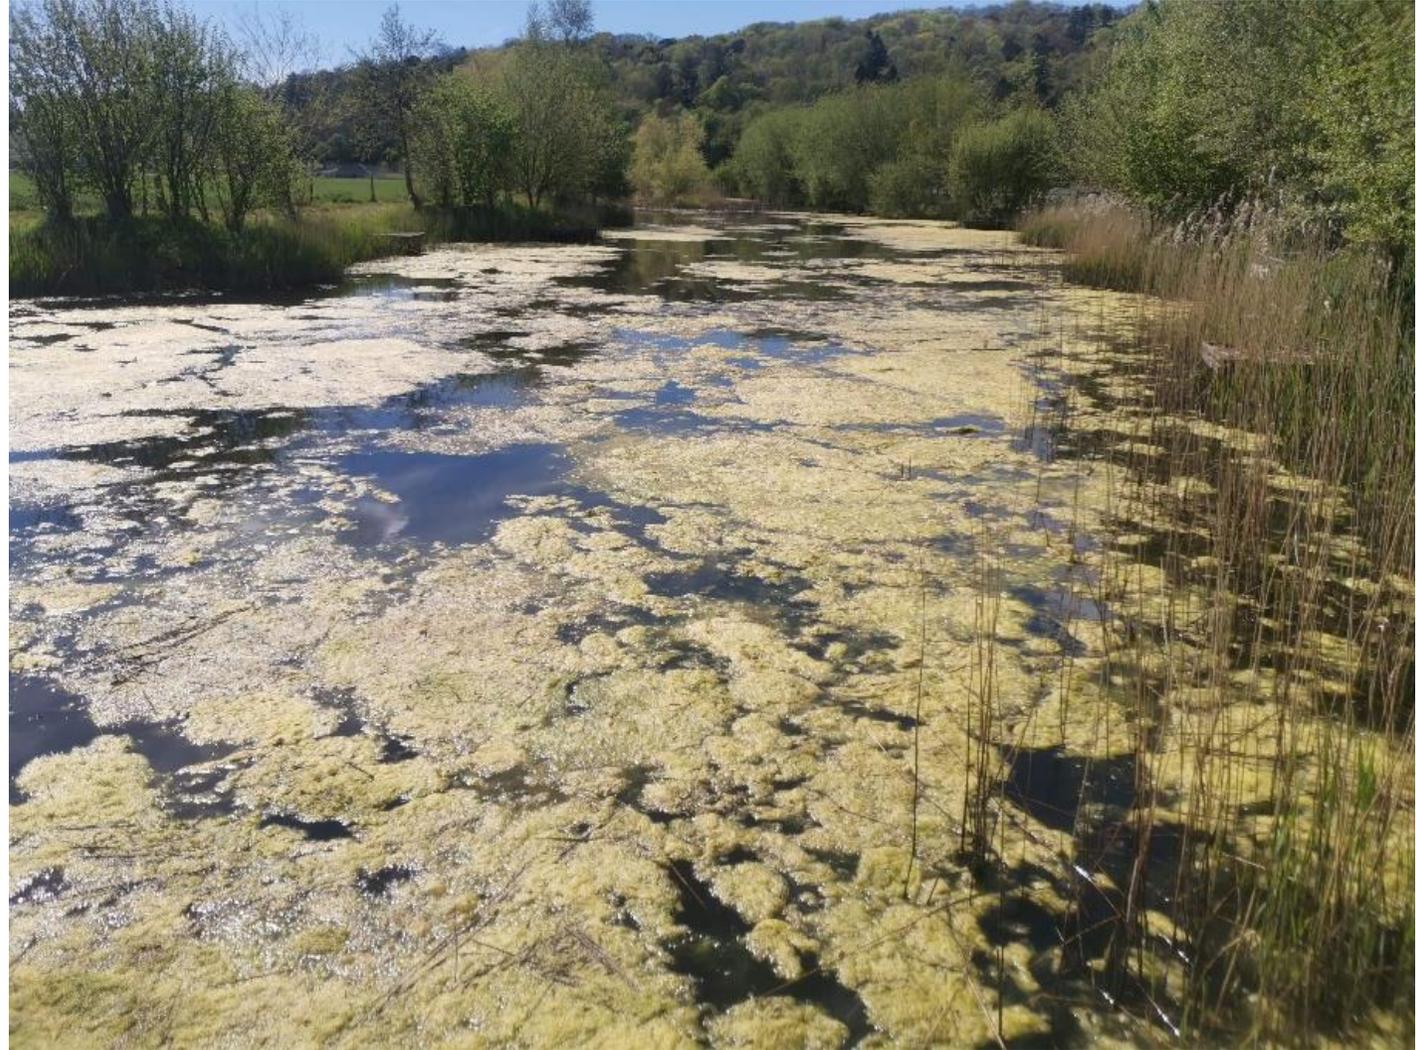
As water temperatures rise during spring, this results in excessive growth of Mares Tail, Blanket Weed and Canadian Pond Weed and significant Phragmites encroachment around the perimeters.

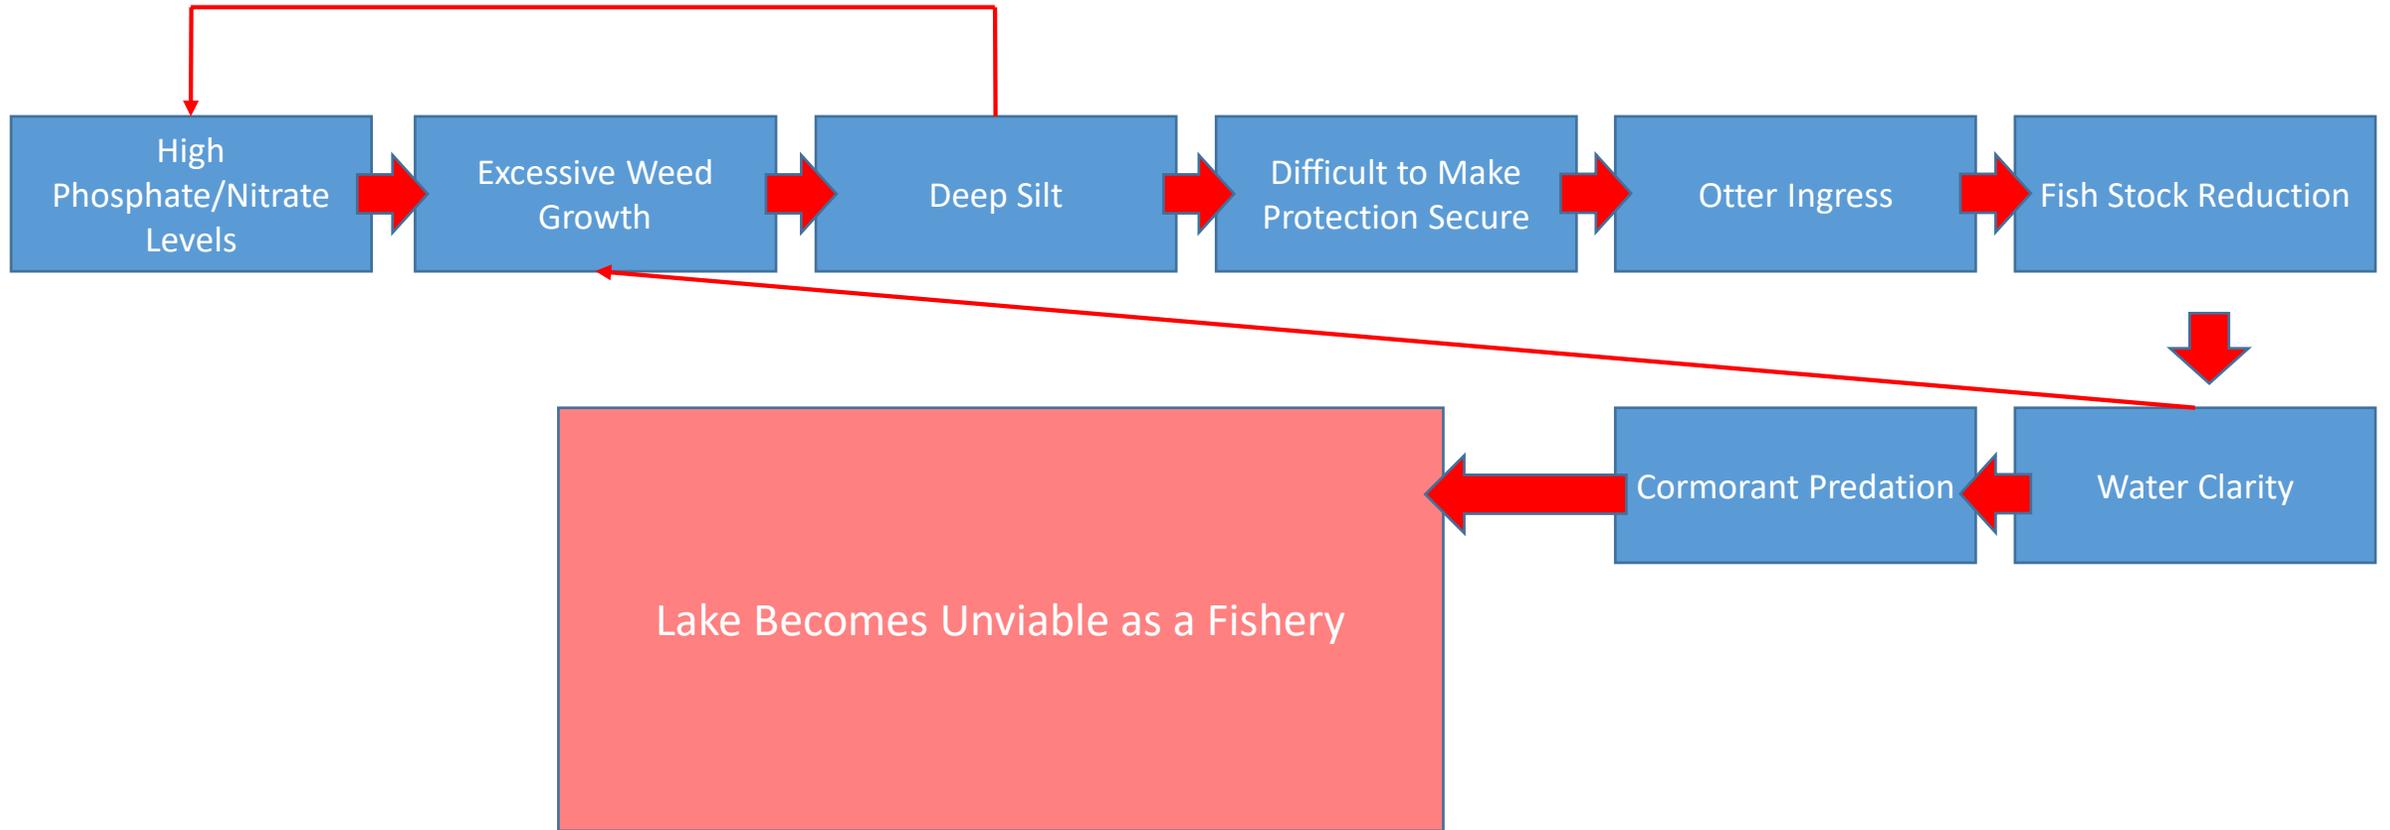
Following study, the club has come to understand the links between these issues:

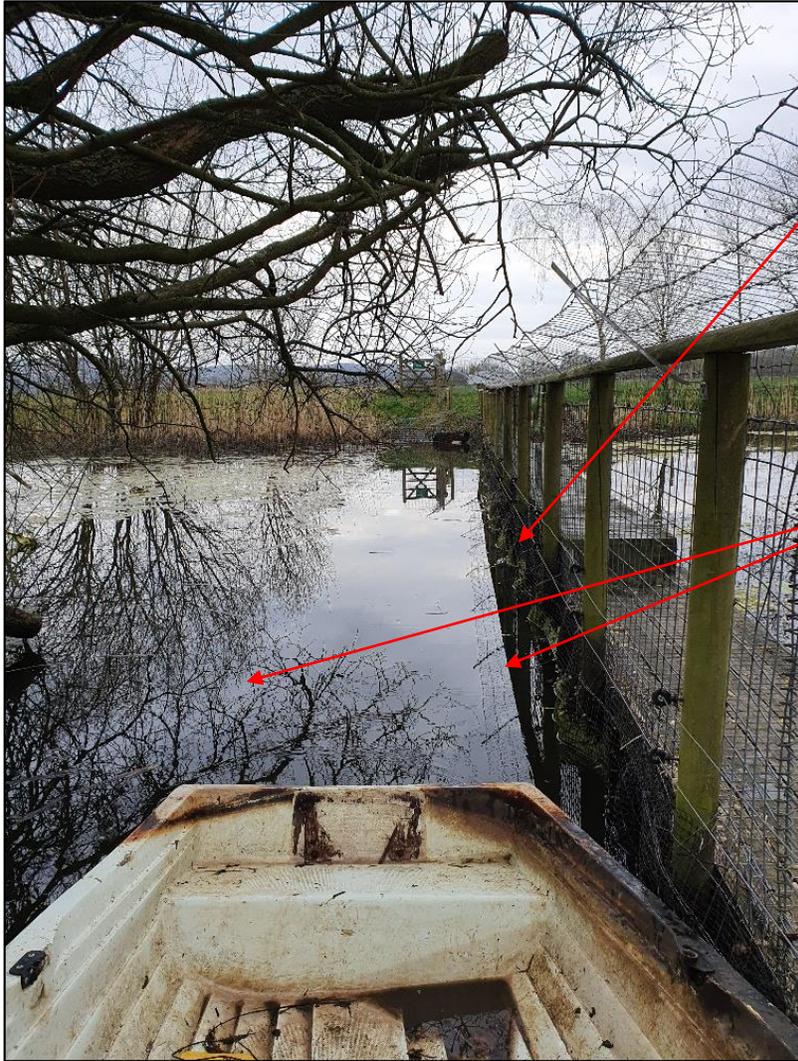
As a final attempt at a simple fix, the club extended the steel mesh further across the bed of the lake:

A profiled and weighted mesh was added on the vertical

A 1.8m wide steel mesh was rolled out across the lake here and weighted down to the lake bed with concrete blocks.

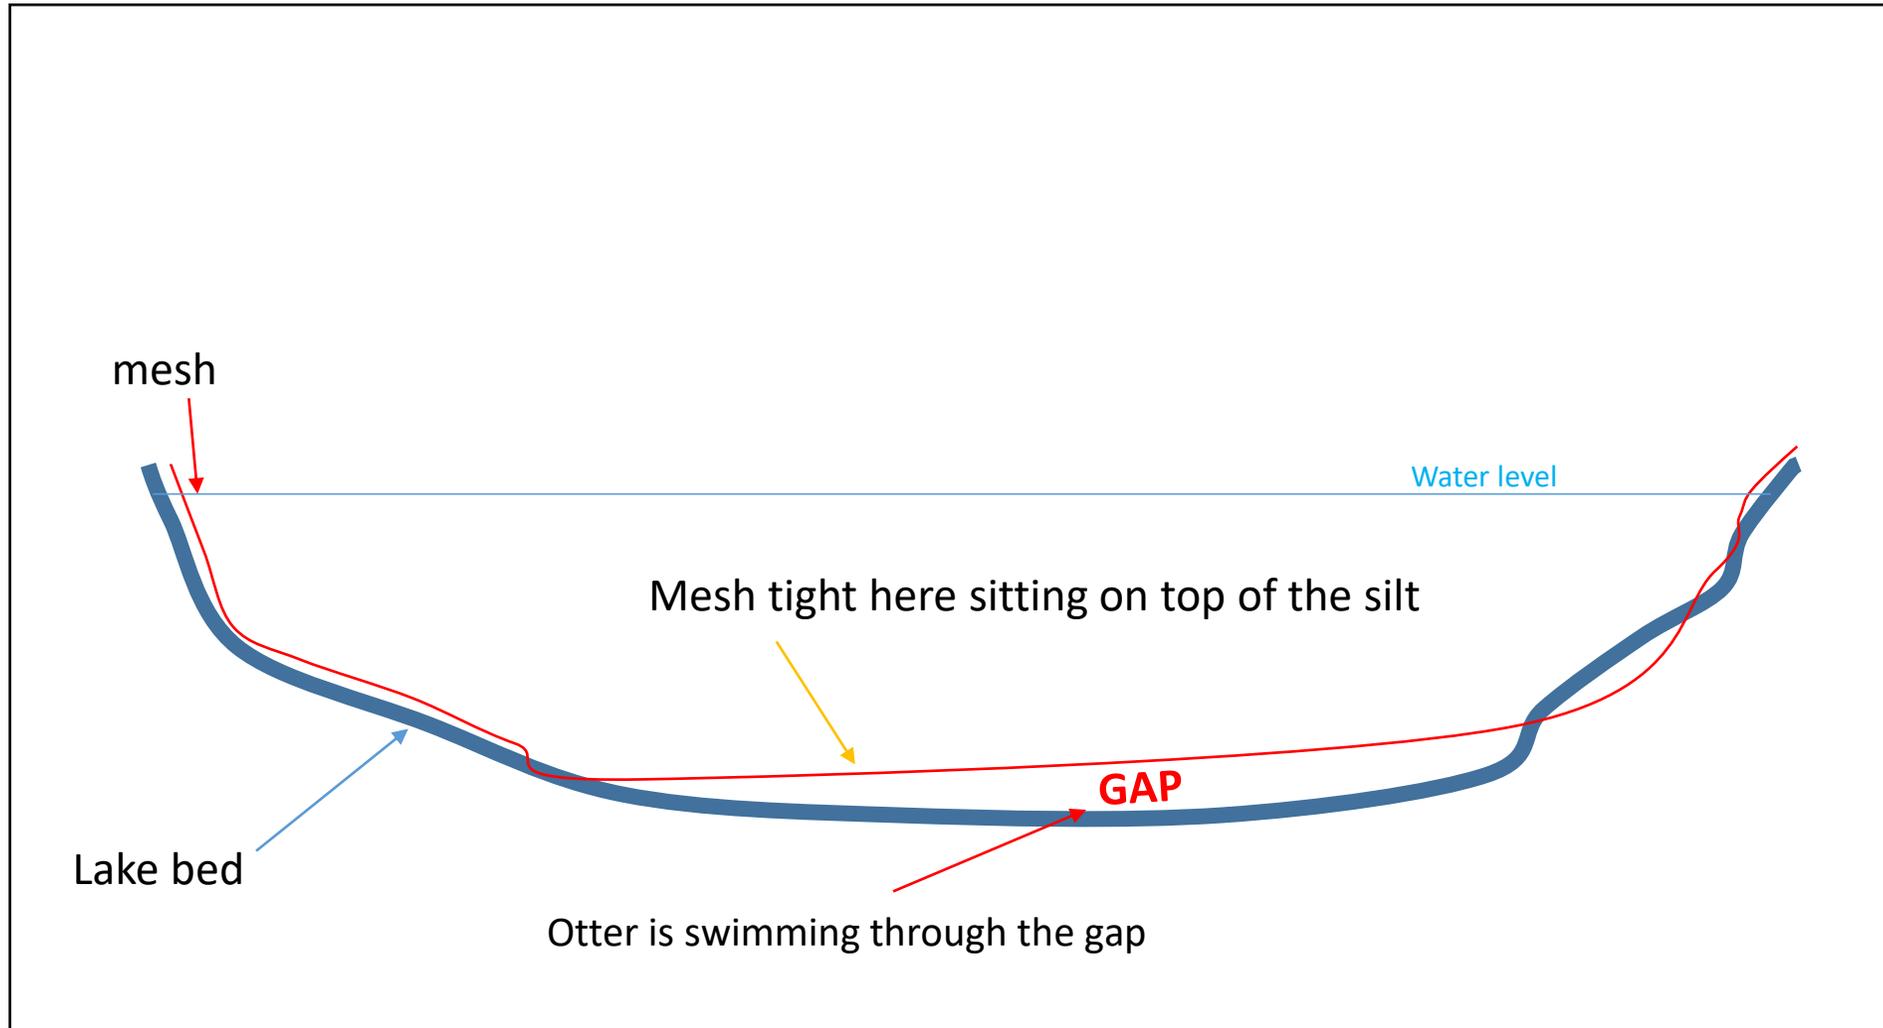
Using a boat and long poles, a survey of the lake bed was carried out. It was discovered that the mesh is sitting on top of circa 45cm of silt on the lake bed. Despite further attempts to pin this down with posts, it has proven impossible to close this gap:

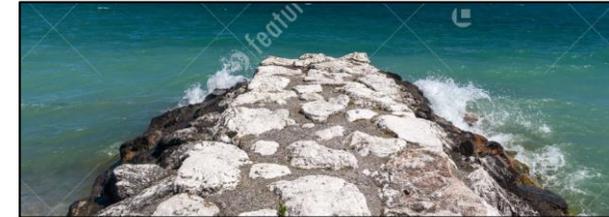
1. Drain Lake – the proposal is to drain the water from the lake, using a fishery specialist to hold remaining fish stocks. The water would be removed via the existing drainage system (this method has already been validated by the EA) using pumps.
2. Construction Solution
 1. Create a solid stone bund, replacing the existing wooden bridge. This (with a piped water levelling system), will provide a solid basis for an ‘above water’ otter protective fence to be constructed on top of. Furthermore, this solid bund, in replacing the old narrow bridge, will improve access to the south side of the lake. The bund would be constructed to disabled access specifications as laid out by the BDAA (WADAA already has a very good working relationship with the BDAA from previous projects). This will require 120 tonnes of stone to complete.

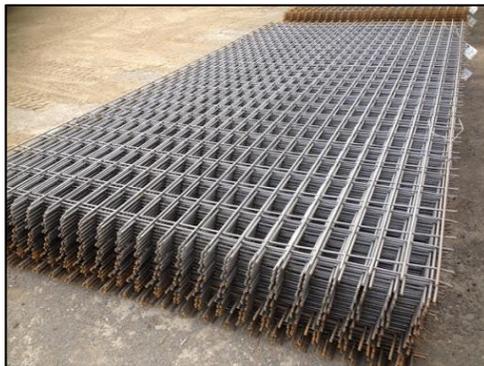
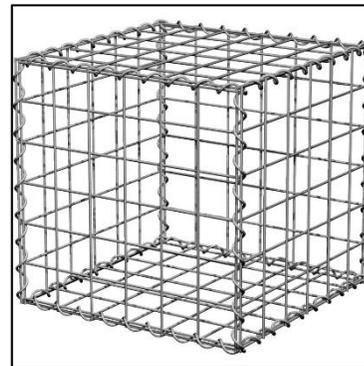
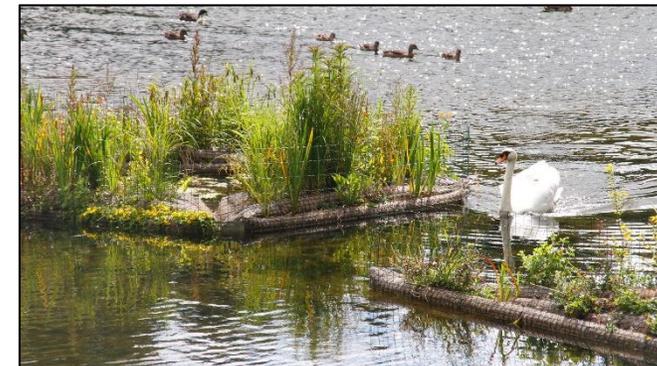
2. Create 2-off, 25m² caged fish refuges placed to the east and western points of the island in the lake. These would be constructed from galvanized concrete reinforcing mesh sitting on the lake bed, topped off with mesh and planted to form an extension to the existing island.

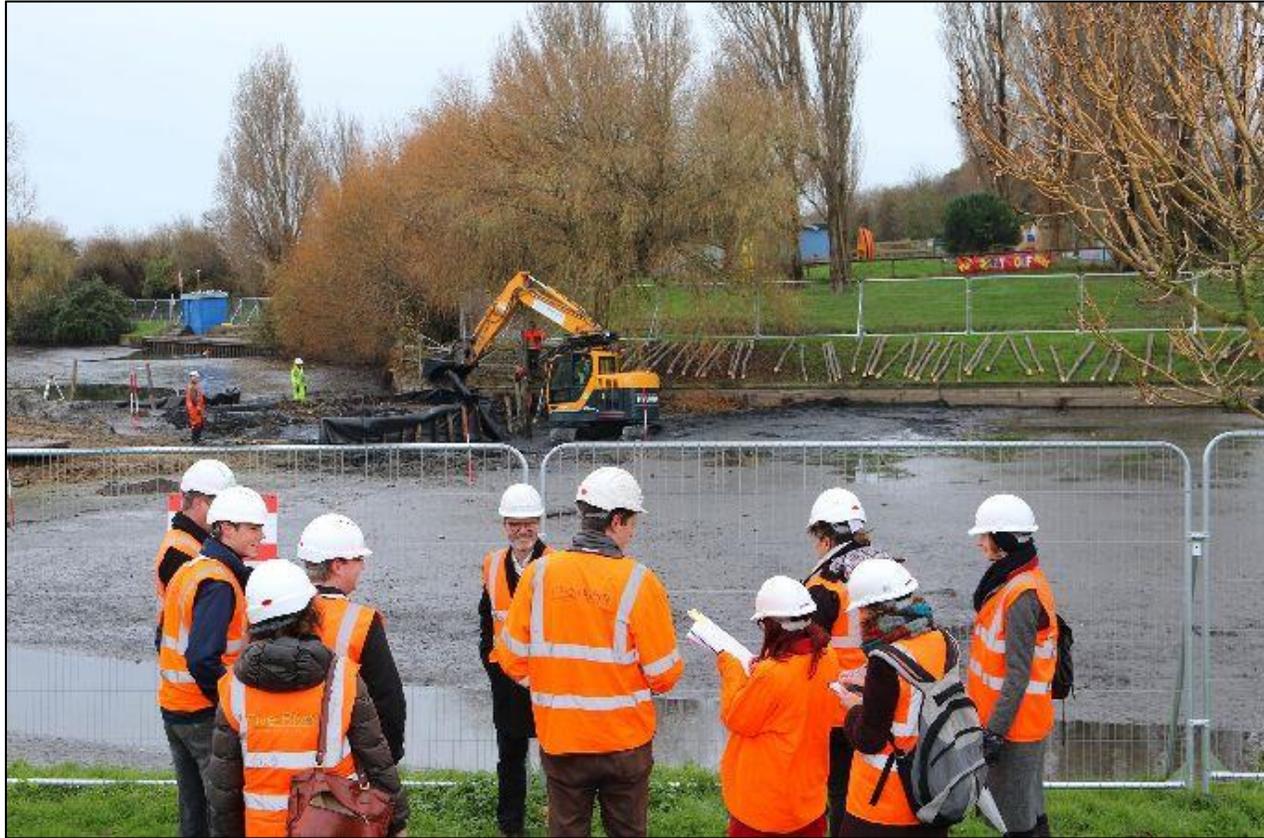
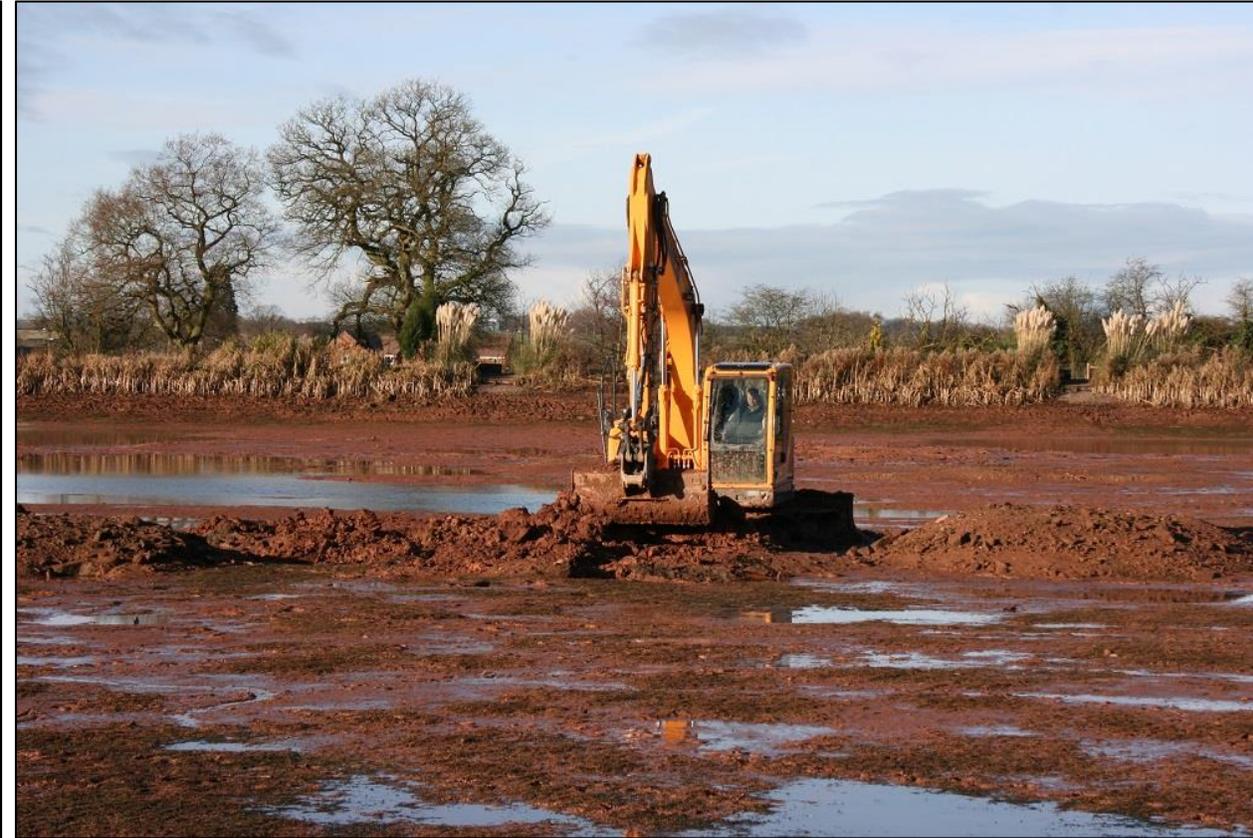
3. Lake Bed Improvements – with the water removed from the lake, the silt from the bed can be scraped, the margins deepened and the invading phragmites removed.

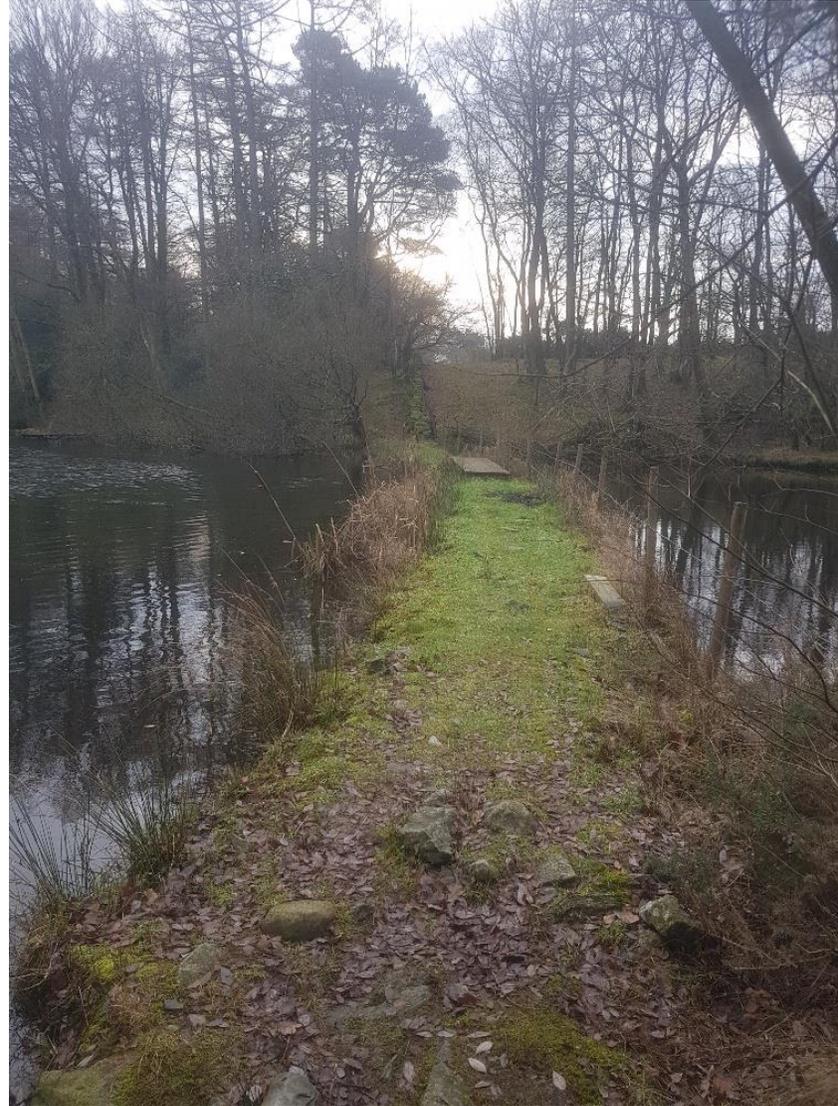
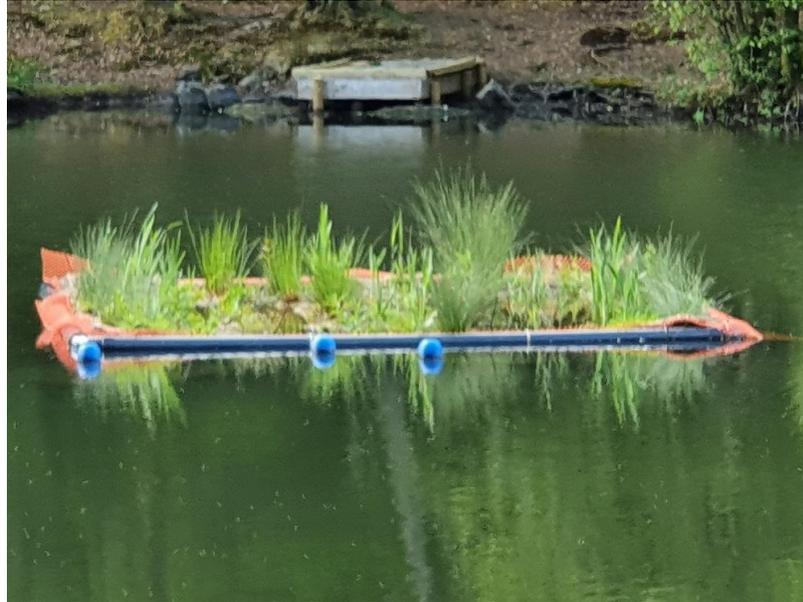
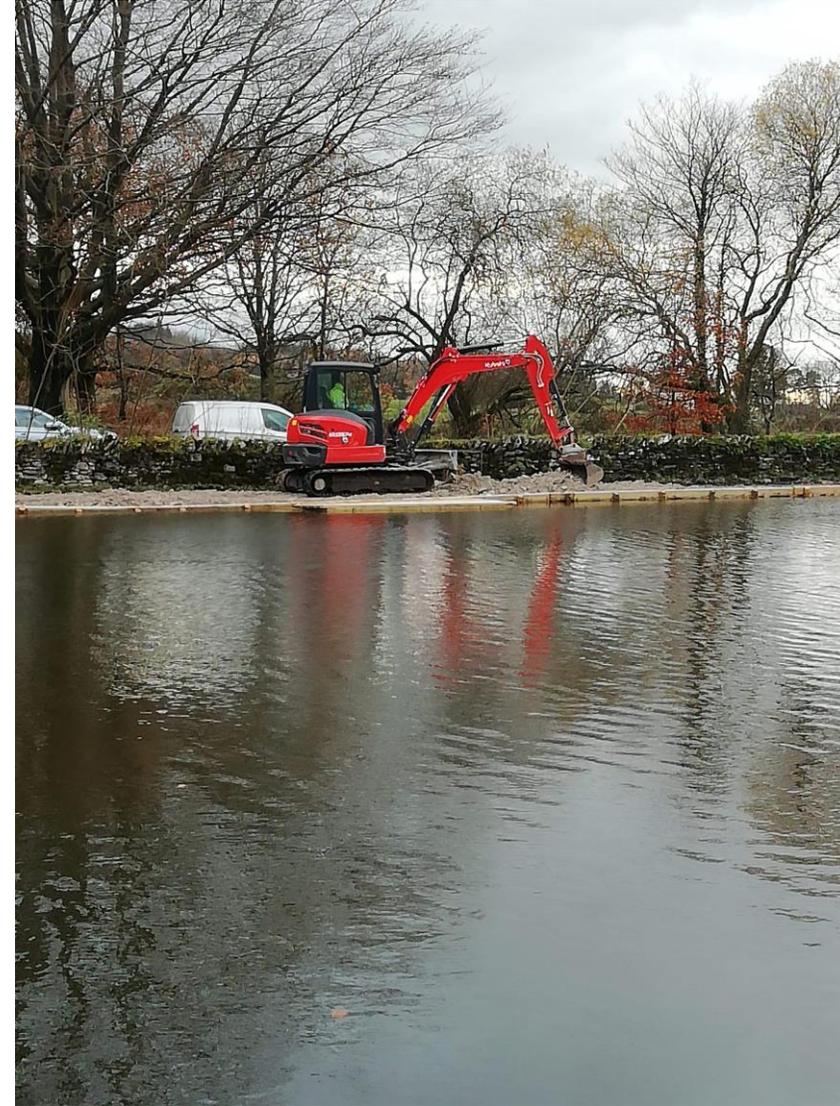
1. Stone bund creation
2. Floating island creation
3. Heavy plant work

WADAA has built up valuable experience in completing this type of work. In 2019/20, a similar type of project was successfully executed at another of the club's lakes, Ratherheath Tarn. In doing so, the club has not only built up a level of knowledge itself, but also made relationships with experts and partners.
